North Peter at Arch Street Stormwater Improvement Project

Project: 6245

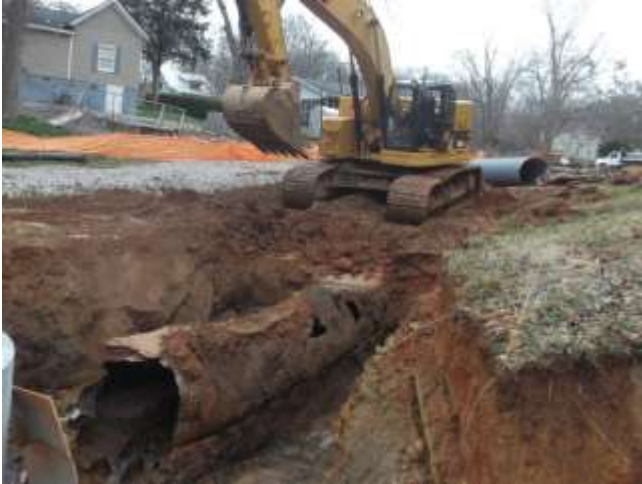
Before

Several sink holes were identified and determined to be a symptom of a failing metal Stormwater pipe along N. Peter and Arch. This project removed the rusted metal pipe system, and replaced it with high performance high density polyethylene piping (HP HDPE), which has an estimated lifespan of 100+ years. Staff then backfilled structures with compactable dirt, top soil, grassed and mulched the area.
