# **Watershed Management Plan**

## **Hunnicutt Creek**

**The Unified Government of Athens-Clarke County**

**December 2010**

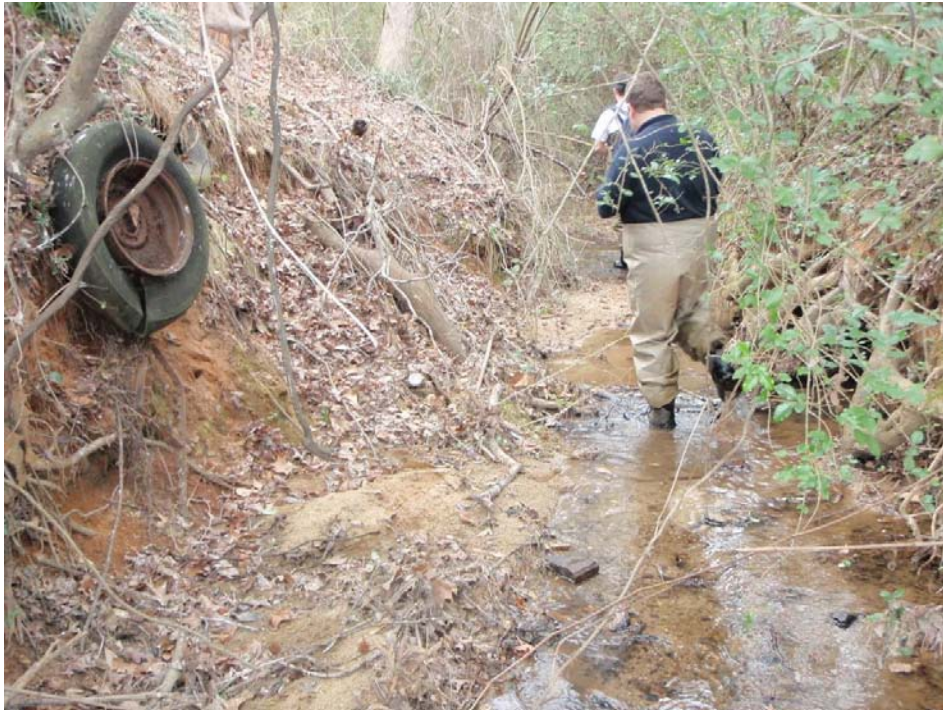
***Photo 3.1.1.4: Silt Covering the Stream Bed***

Hunnicutt Creek near Bel Air Drive

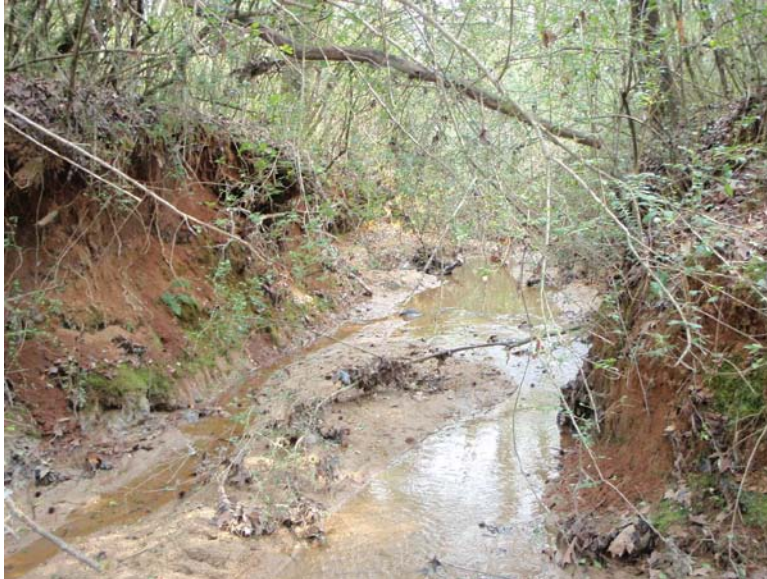
**Photo 3.2.4.2: Poor Stream Habitat**

Low amounts and decreased diversity of aquatic macroinvertebrates in urban streams are caused by the alteration of all aspects of stream habitat. During stream walks in Hunnicutt Creek (see section 3.1), the stream bed was found to be heavily sedimented and aggraded in many reaches. The deposition of fine sediments fills in natural rocky riffle habitat where many macroinvertebrates live. In the Hunnicutt Creek watershed, H1 had a high mean, median and variability in bed sediment size, which corresponded to a "good" score on the index we used to assess macroinvertebrate diversity. This reach (HC 1-ai; Table 4.1)) had one of the highest scores in the reach assessment (50/80; Table 4.1) and little bank erosion was observed.
