# **Watershed Management Plan**

## **Brooklyn Creek**

**The Unified Government of Athens-Clarke County**

**December 2010**

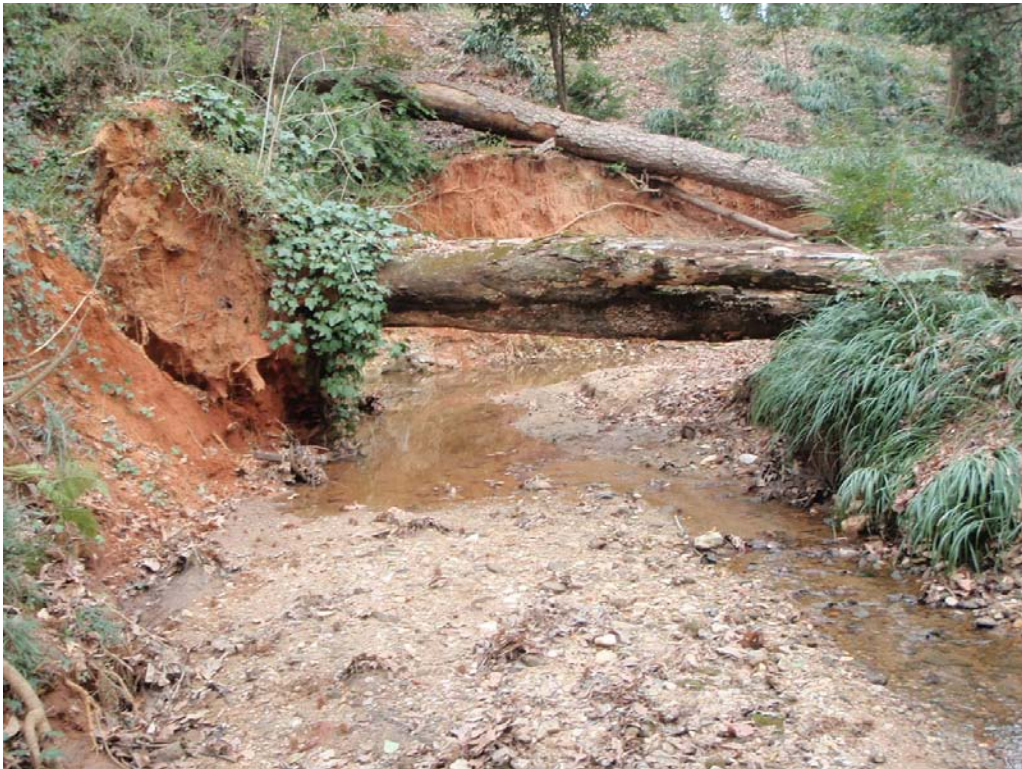
***Photo 3.2.4.2: Poor Stream Habitat***

Impaired aquatic life in a stream is most often directly a result of degraded aquatic habitat. According to the data collected during the stream walks, the stream bed of Brooklyn Creek was found to have some problems including sedimentation and aggradation. When compared to other streams in Athens-Clarke County though, the banks and bed of Brooklyn Creek have a significant amount of bedrock intact, preventing widespread and severe erosion. In all reaches sampled for macroinvertebrates in Brooklyn Creek, we found relatively intact banks and a large amount of variation in bed sediment sizes, from sand to large boulders (Table 3.2.3.2). Many macroinvertebrate taxa live in riffle areas created by water moving over the stream bed material while others live in sandy pools. A wide range in bed sediment sizes provides a variety of habitat for different aquatic organisms that have different life history characteristics.
