160 Satula Ave.
Athens, GA 30601-1728

Description of proposed work:

There are two chimneys on the home, the main center chimney for the two fireplaces, and a small chimney in the rear left corner of the home. The chimney in question is the small one above the kitchen.

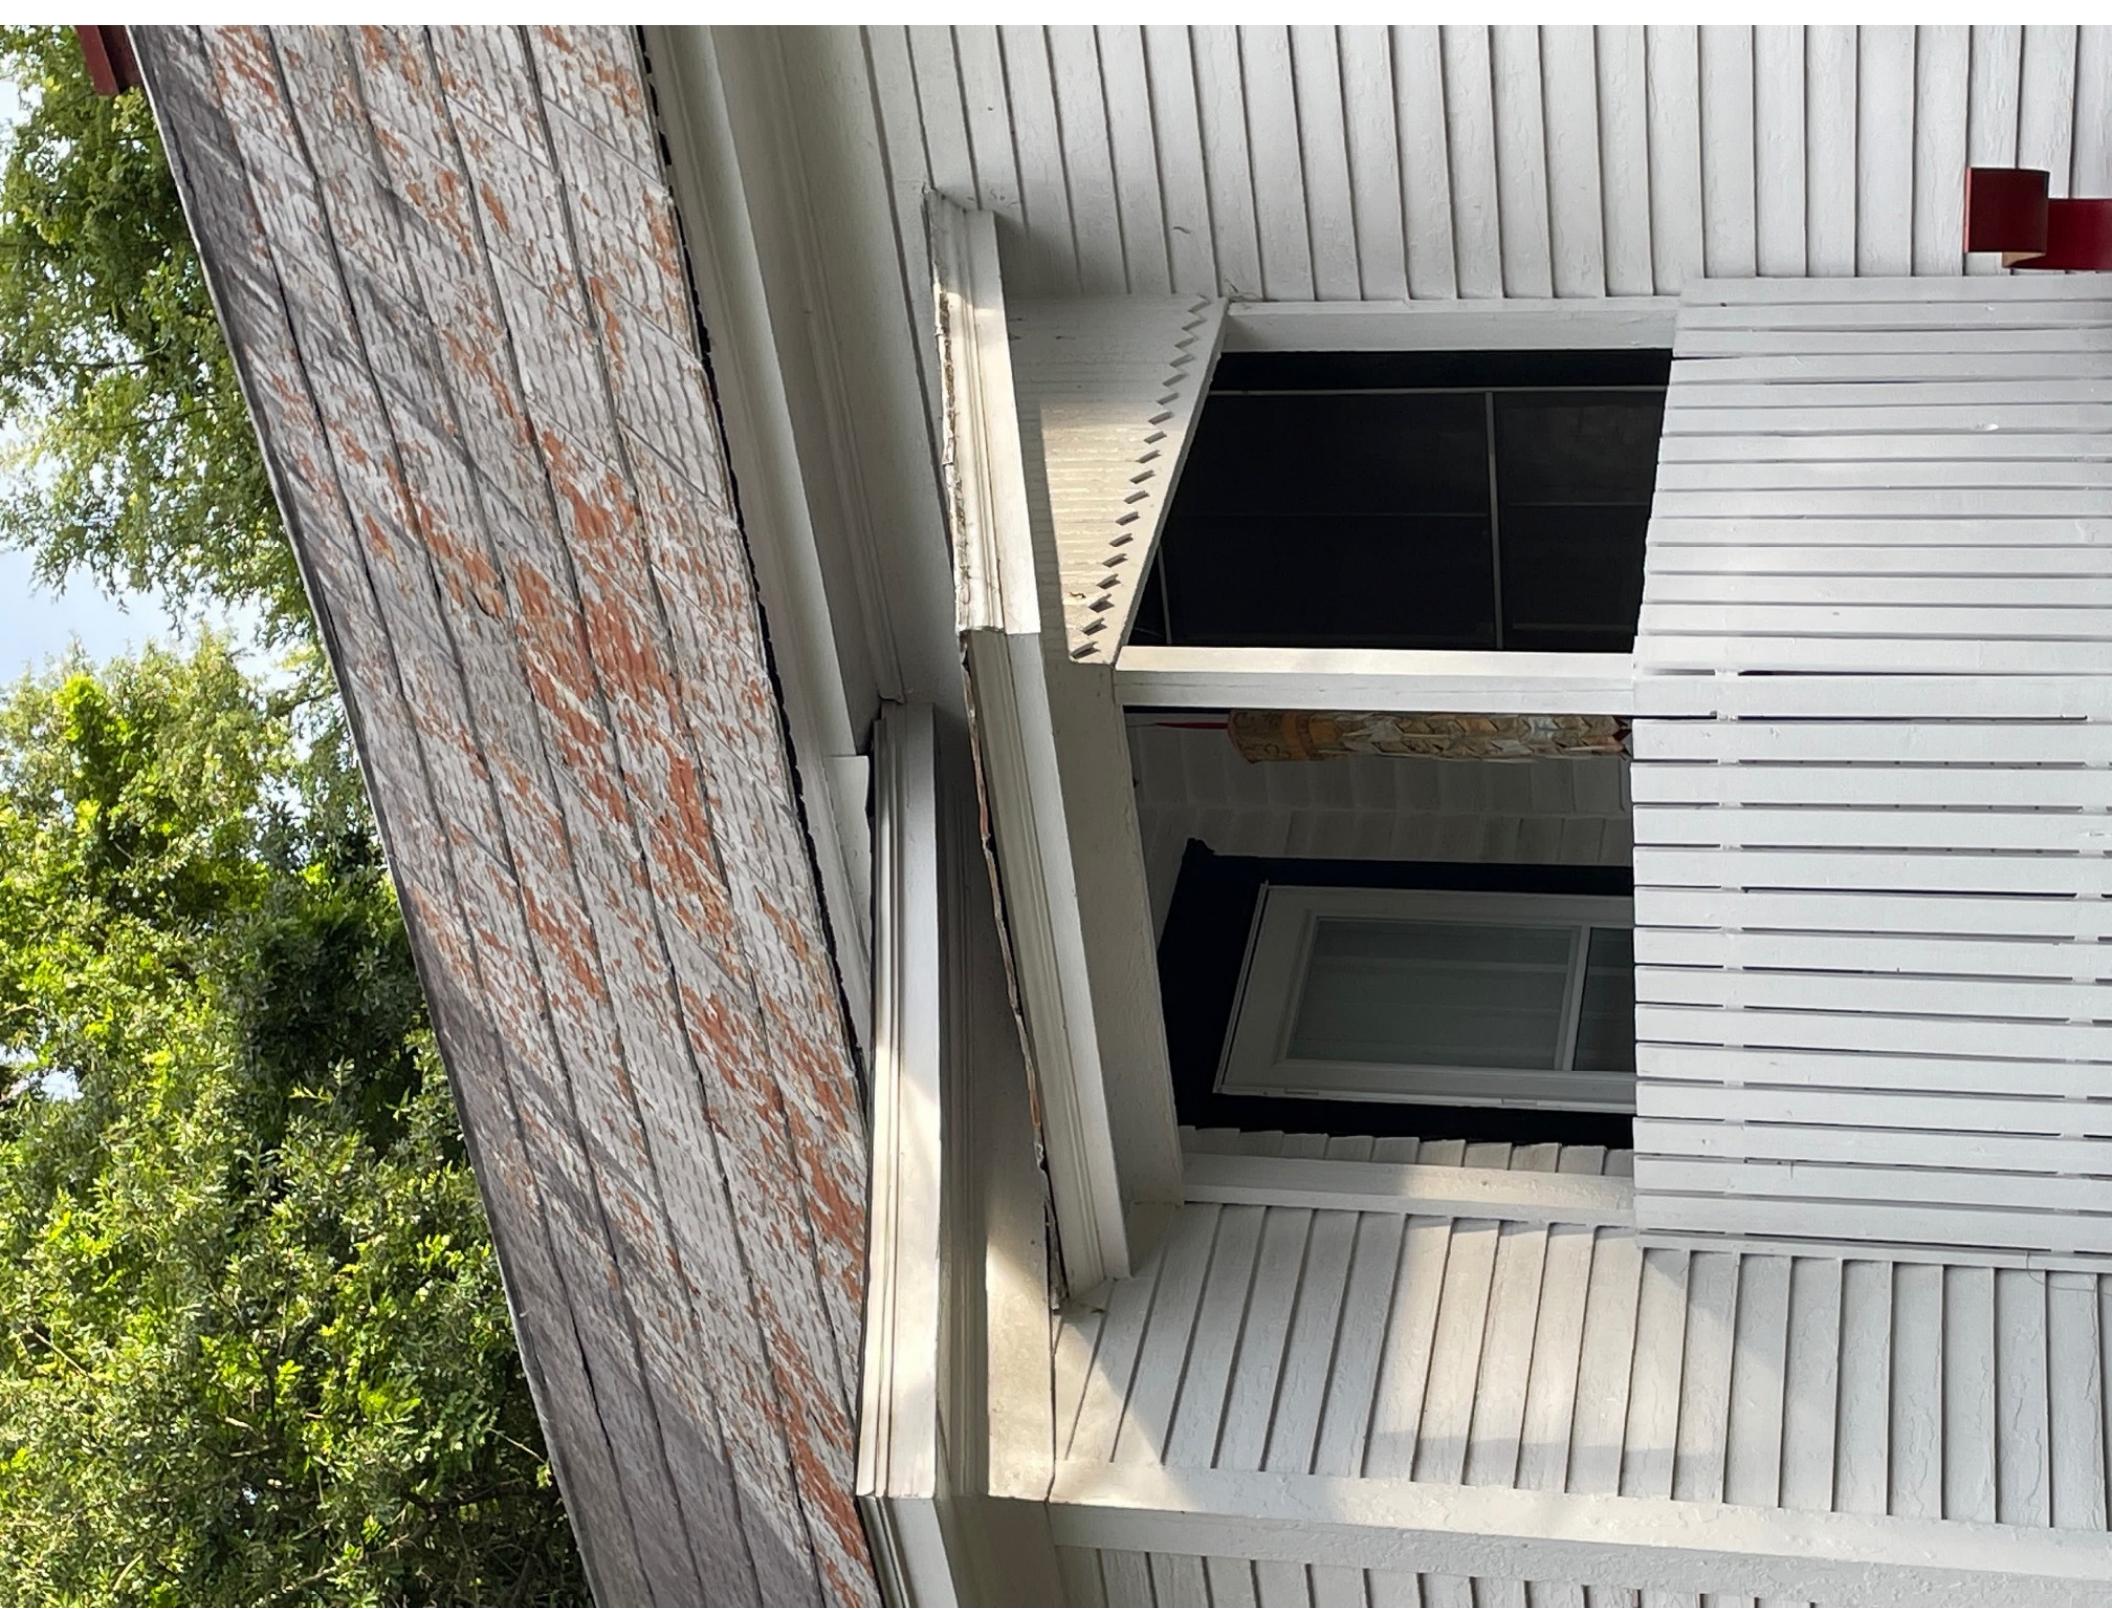
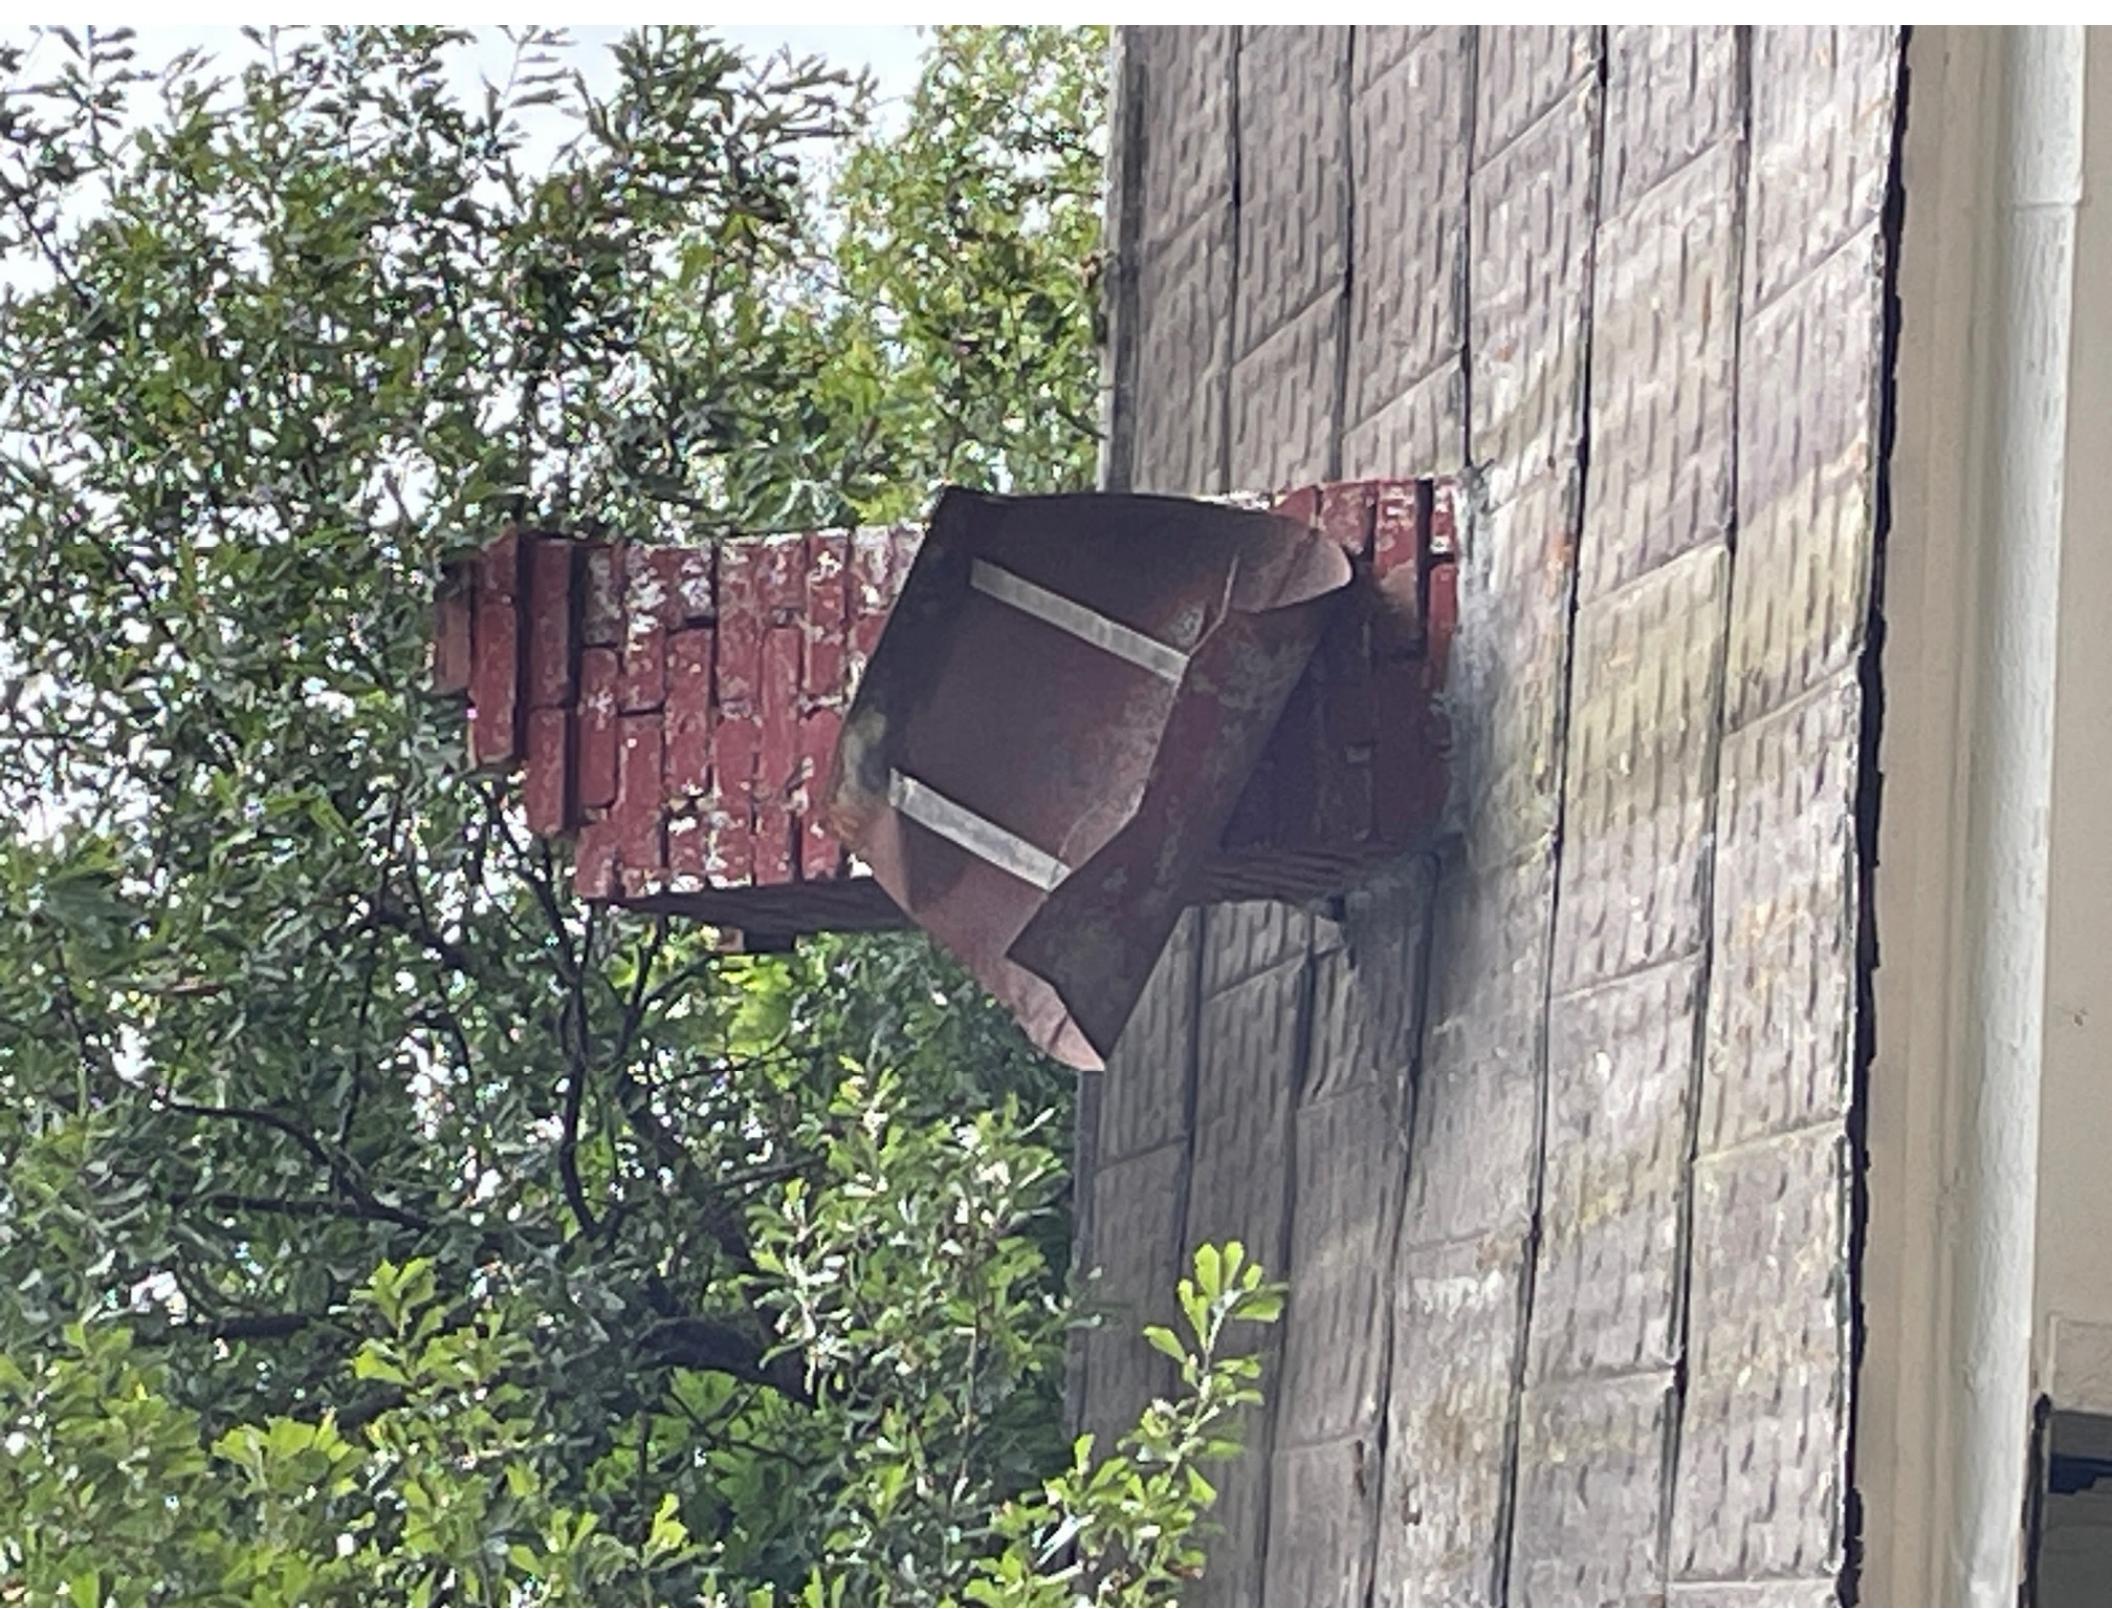
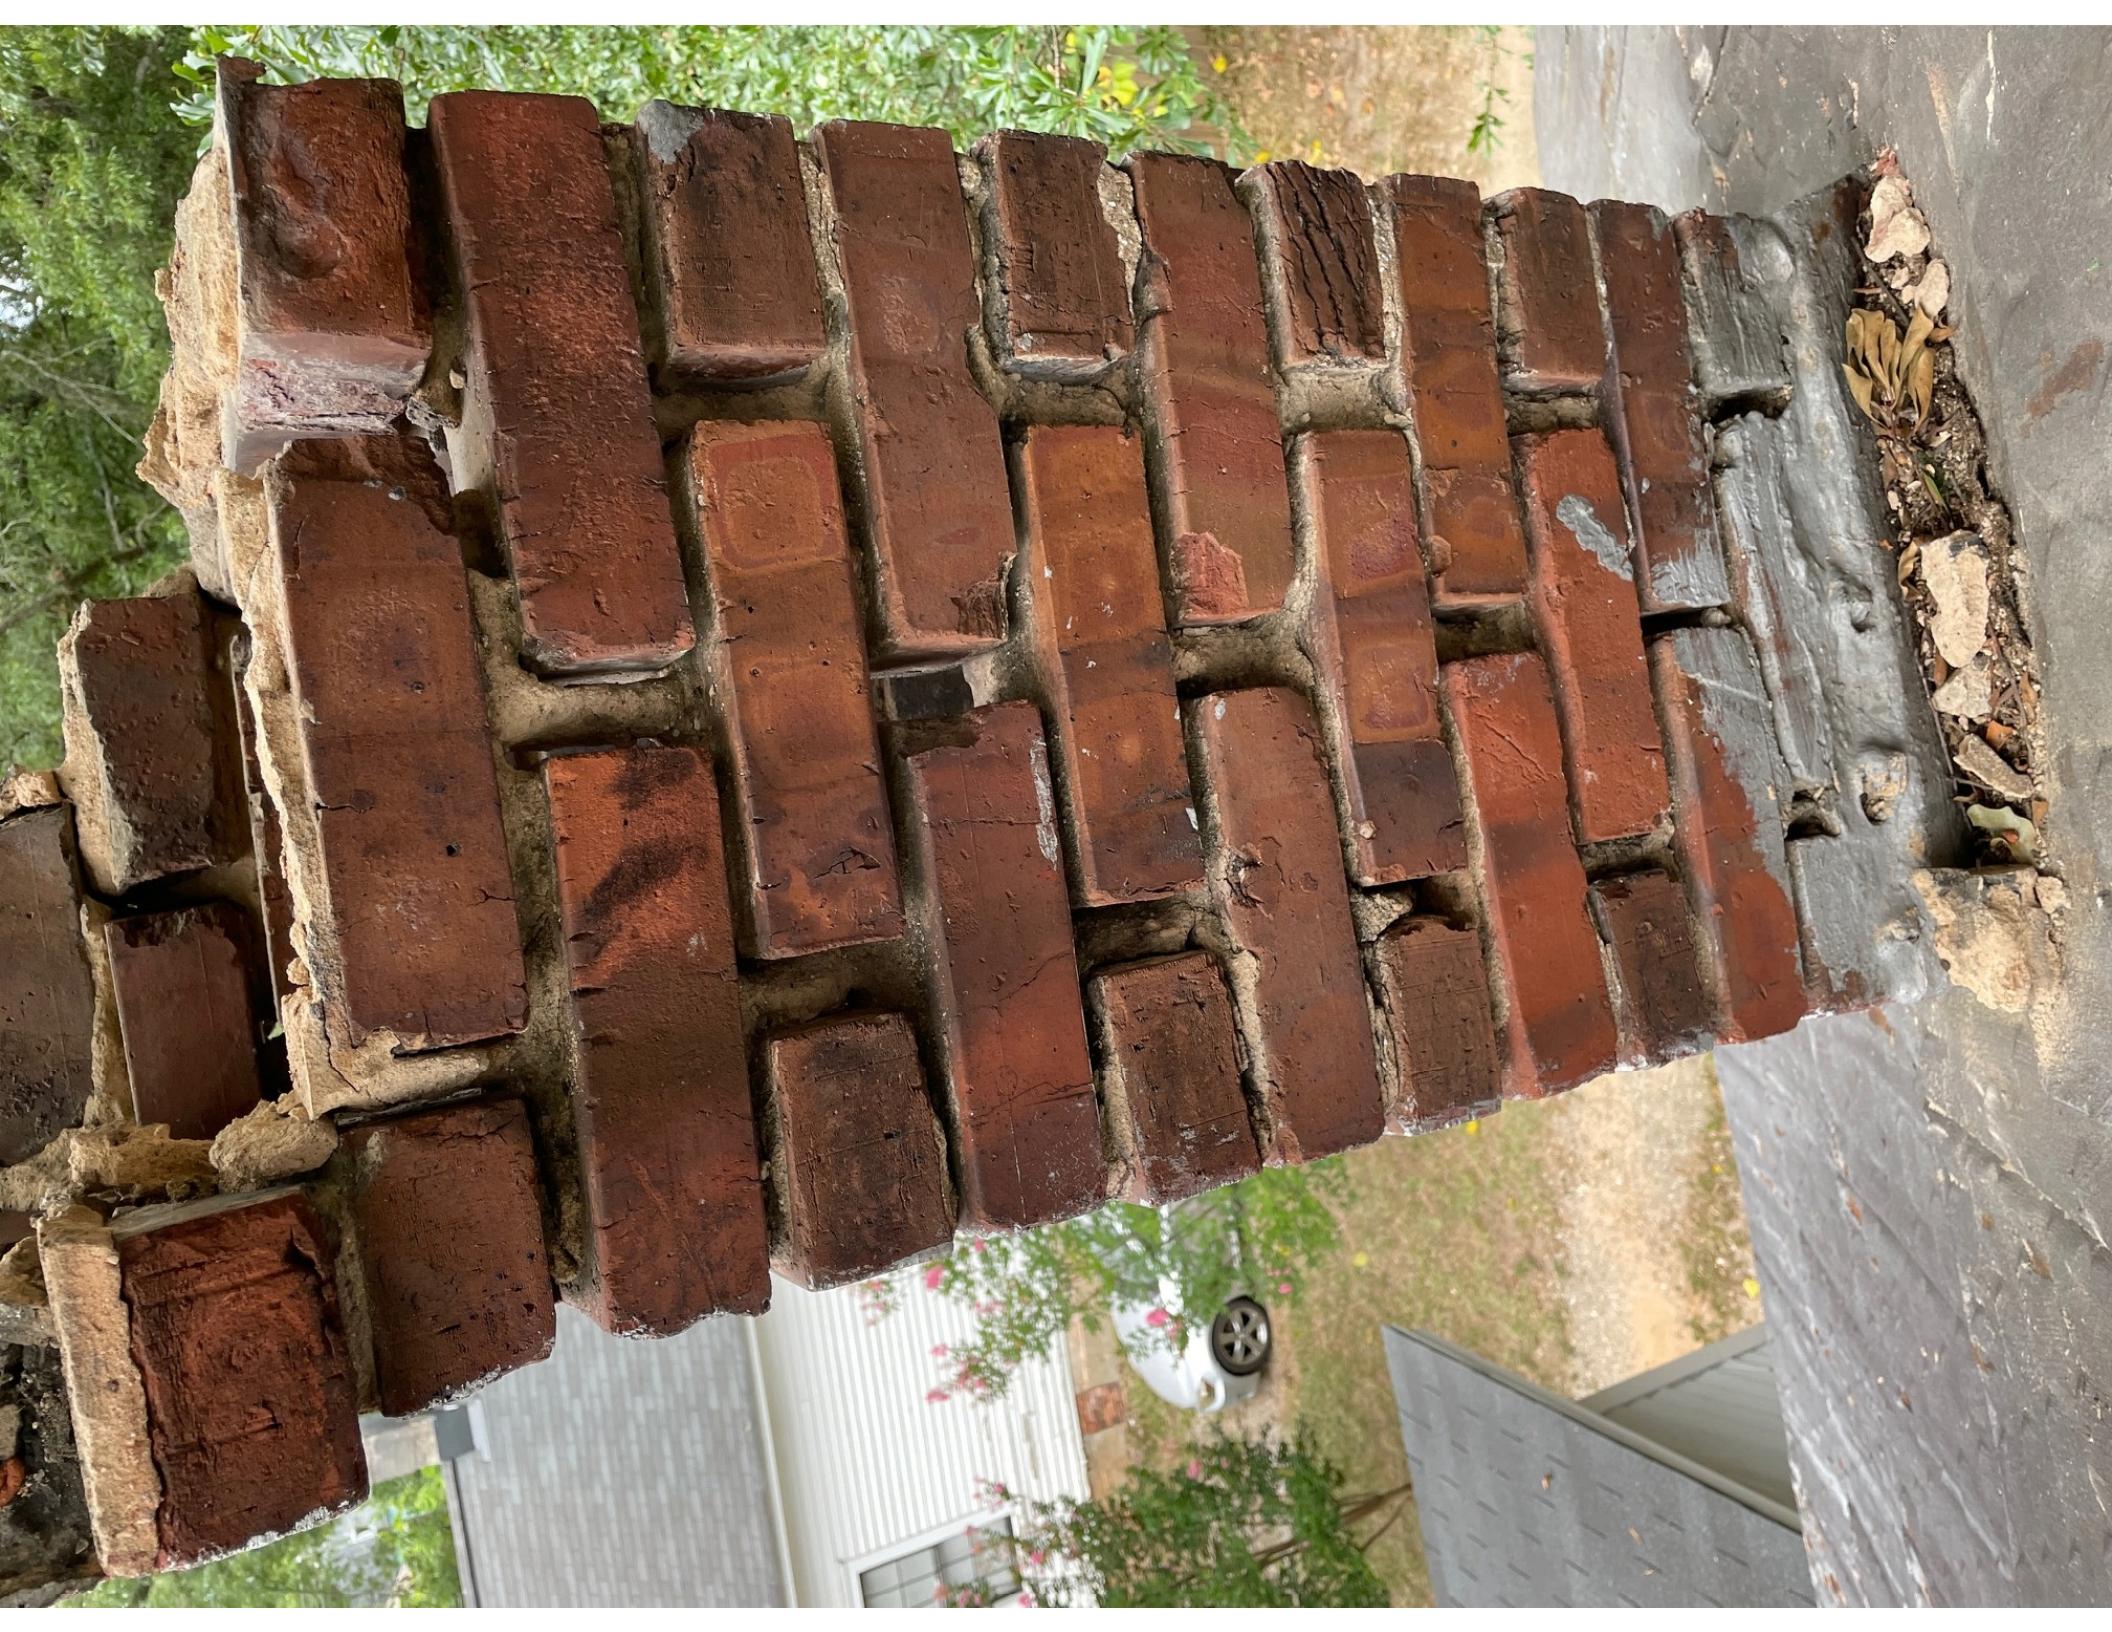
The chimney is supported by an iron hanger that sits above the kitchen ceiling on two ceiling joists. There is a thimble in the ceiling into the bottom of the chimney for the attachment of a stovepipe. Inside the house the chimney isn't visible from below except the thimble on the kitchen ceiling, which hasn't been used in many years. Outside, the chimney is visible from the left side but is near the back of the house and we feel is not an obvious or important architectural feature of the home.

Additionally, from the weight of the chimney on two ceiling joists for 110 years the joists have sagged resulting in the plaster ceiling cracking and needing ongoing repair and repainting.

The mortar has failed, the bricks are moving apart from each other, and the chimney has begun to collapse. To maintain this chimney would require completely removing it and replacing it with a new chimney. As we do not see the chimney as being architecturally significant to the home and replacing it would also include replacement of the kitchen ceiling joists and plaster ceiling, we would like to remove the chimney.

We would repair the roof penetration with existing matching stamped tin roofing tiles. There is a small side porch on the north side of the house that has the same roofing tiles as the main roof. We propose removing the roofing tiles from this roof and using them to cover the chimney penetration. In their place we would add appropriate metal roofing to the side porch roof, which isn't visible from the ground.
