# Draft Watershed Management Plan for Walton Creek

## Athens-Clarke County

### April 2018

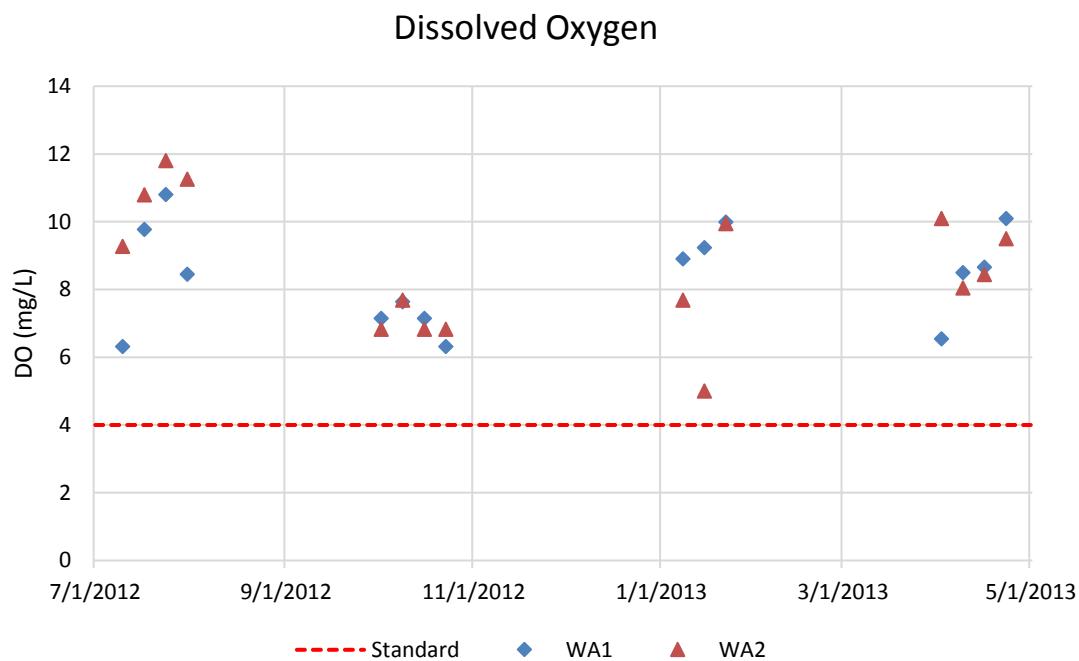
**Figure 2-8. Dissolved Oxygen Grab Sample Results for Walton Creek Stations**

Plots of the raw grab sample data for DO, FC, pH, and temperature collected at each station are shown in Figure 2-8 through Figure 2-11. Data for station TR2 was collected from July 2012 through April 2013. The full set of tabulated data is provided in appendix C.

Results of the water quality sampling effort suggest that surface waters in the study area meet the DO, pH and temperature standards adopted by the State of Georgia. Average concentrations of DO and average measurements of pH and temperature in Walton Creek are well within the state standards. All individual measurements are also within state standards.

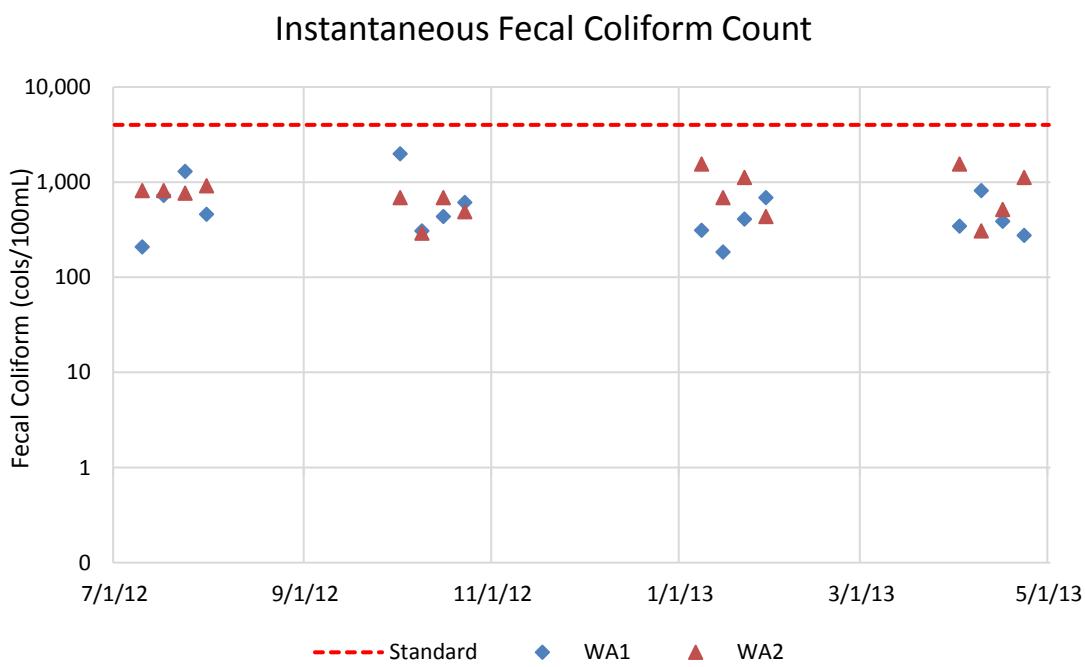
**Figure 2-9. FC Bacteria Grab Sample Results for Walton Creek Stations**

FC geometric means indicate that both Walton Creek stations comply with the November-through-April standard but neither station complies with the May-through-October standard (Table 2-5). Average total nitrogen (TN), total phosphorous (TP), and conductivity results meet the standards at both stations. Average total suspended solids (TSS) concentrations slightly exceeded the standard of 13 mg/L for station WA-2.

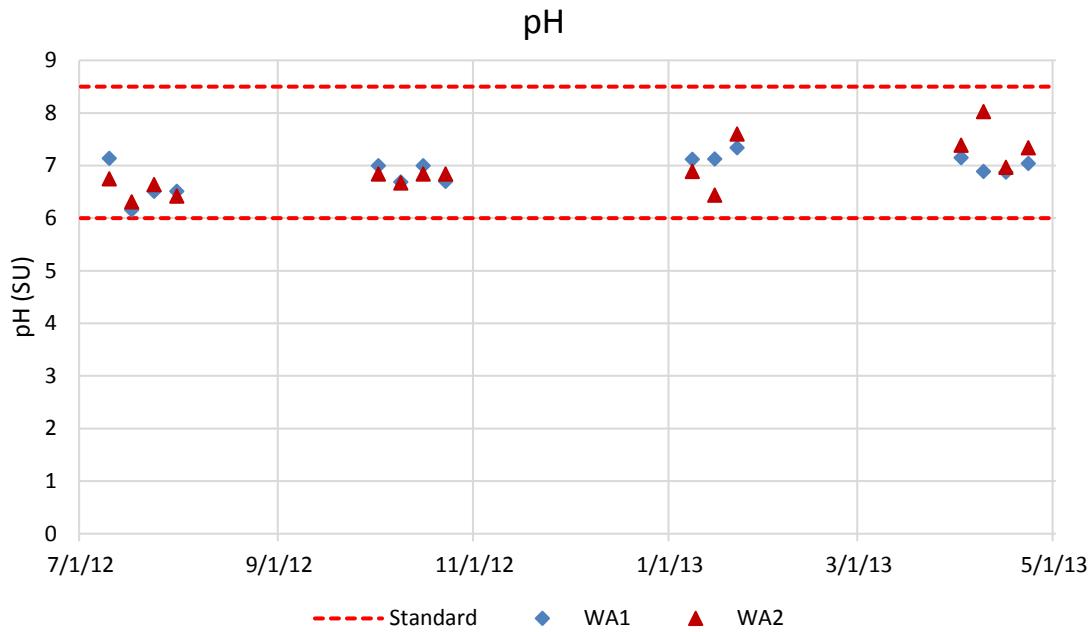
**Figure 2-10. pH Grab Sample Results for Walton Creek Stations**

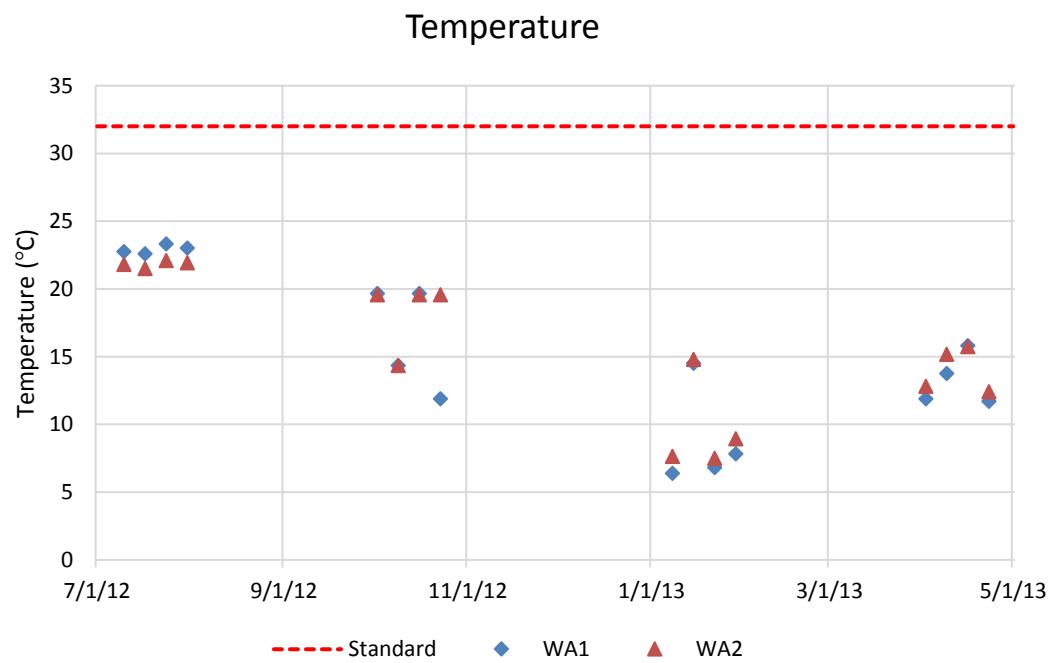
**Figure 2-11. Temperature Grab Sample Results for Walton Creek Stations**
